FEMA

Mitigation

...in New Hampshire

Bartlett Loop Road work protects public safety, waterway

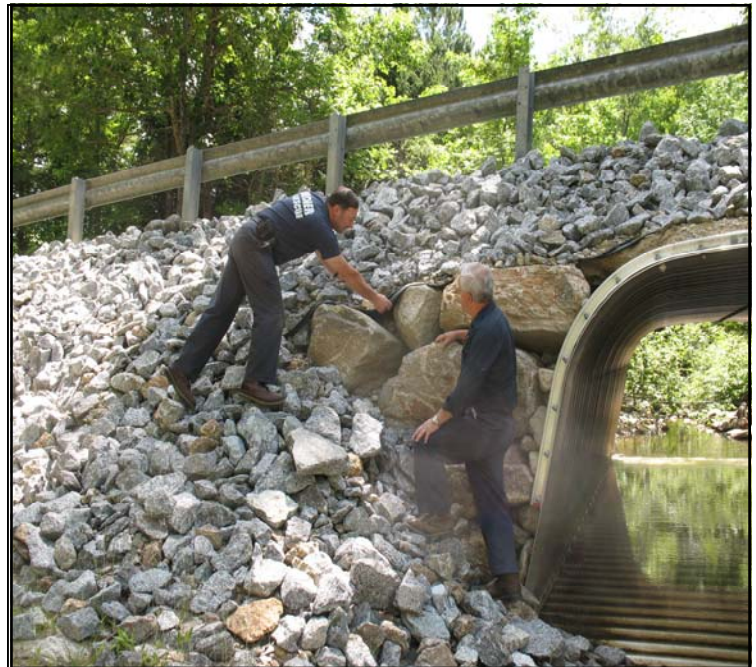
Emergency Management Director Edward Mical and Public Works Director Allan Brown show the placement of geosynthetic material in the roadbed of Bartlett Loop. Photo by Bridget Weber, FEMA.

The mitigation measures which included a hydrology study, added an additional \$31,000 to the estimated \$63,898 total cost of the project. The work crew installed a standard aluminum multi-plate box culvert with much higher flow capacity. The crew installed a rubber membrane between the culvert and the road bed to prevent salt from corroding the aluminum culvert. And true to the thrifty nature New Englanders are known for, the project came in \$8,000 under budget at \$55,784, with Public Assistance providing a grant of \$41,838 to the town for the project.

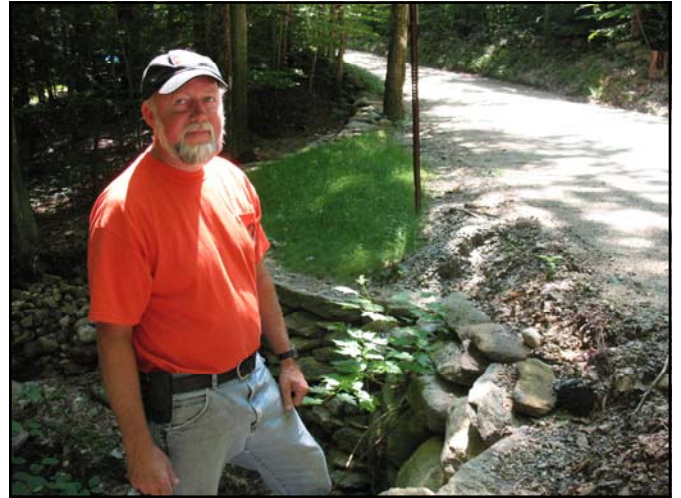
Road Agent Tim Fiske stands next to a repaired stone culvert on Fish Road where geotextiles were used in the roadbed. Photo Bridget Weber, FEMA.

cer. The historic character of the culvert would be retained and preserved with little visual impact from the repair by rebuilding with the original stonework. And to help prevent continued damage to the culvert in future flood events, they were able to add a cement culvert beside the stone culvert, engineered to be a secondary flow-through when floodwaters backed up behind the stone culvert.

But Fiske wasn't finished with the job yet. In addition to a larger opening for floodwaters to flow through under the road, the road itself needed help to stay put in the event floodwaters would overtop it. Using geotextiles to hold the gravel roadbed in place and reduce erosion seemed the right option.

First, the roadbed was shaped to confine the overflow to the armored area by making a long shallow depression in the road over the culverts. Fiske and his road crew then installed 400 square feet of geocell on top of the roadbed at that point. The geocell material has cells like a honeycomb and the cells are filled with stone or gravel. The intent is that when water runs over the road, rather than separate pieces of gravel or stone for the rushing water to carry away, the filled geocell material acts as a whole unit to hold the roadbed in place.

"We stretched the geocell over the roadbed, pinned it in place and filled it with crushed stone," explained Fiske. "Then we overlaid it with three inches of crushed gravel."

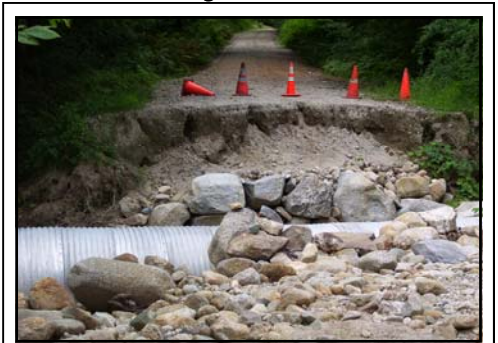
under Bartlett Loop Road. The surging floodwaters pushed gravel fill and boulders downstream. A gaping hole replaced the roadbed. Floodwaters deposited hundreds of yards of gravel downstream in wetlands, changing the course of the stream over 160 foot reach.

The floodwaters from the 2006 Mother's Day Storm tore a hole through Bartlett Loop road. Photo by Bridget Weber, FEMA.

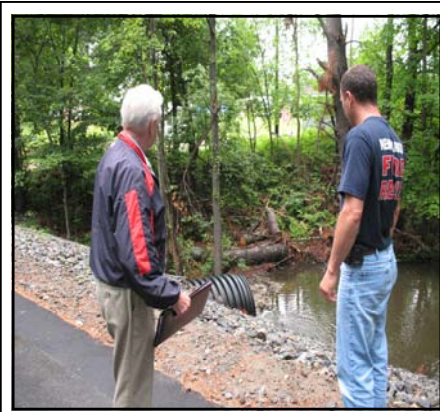
Rick Malasky (right) shows FEMA mitigation officer George Brosky (left) the larger culvert that was installed on Langs Lane in 2006. Photo by Bridget Weber, FEMA.

The solution to the reoccurring problem was to replace the culvert with a larger one. The crew installed a larger, 48-inch culvert and provided additional shoulder protection to prevent erosion. The mitigation measures added \$3,885 to the cost of the project, bringing the total price tag to \$25,401.

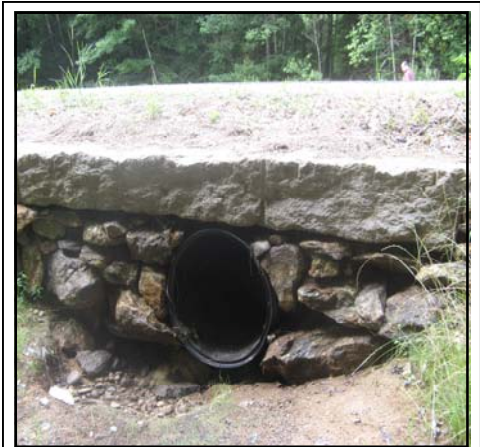
The upsized culvert on Quaker Road is stabilized with New Hampshire granite. Photo by Darby Duffin.

In May 2006, severe storms and flooding from the Mother's Day Storm left gaping holes in several roads in New Durham. The town combined funds with FEMA assistance to mitigate three damaged sites Quaker Road and another on Drew Road. Mitigation measures included installing new, larger culverts and adding an additional culvert to one of the sites. All the culvert upgrades proved effective in handling the water flow during the 2007 spring flood event.
